Performance of building cladding in urban environments under extreme winds

By Tiphaine Williams^a and Ahsan Kareem^a

^a*NatHaz Modeling Lab., Univ. of Notre Dame, 156 Fitzpatrick Hall, Notre Dame, IN, USA*

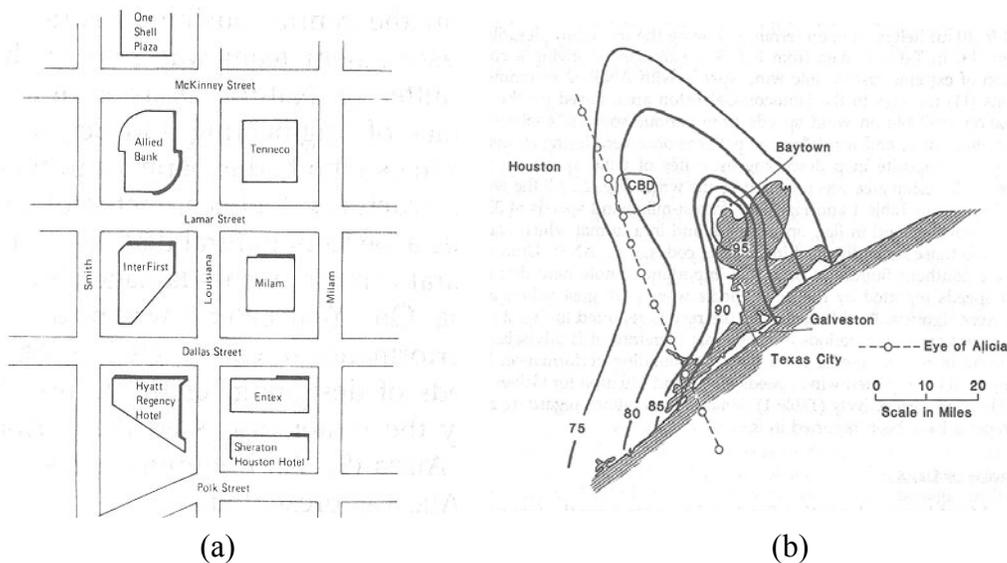
The second author was responsible for collecting information regarding the structural aspects of the damage caused by Hurricane Alicia in the Houston-Galveston area [2]. Observations of building cladding, especially in the central business district (CBD) of Houston, showed that glass cladding experienced the most damage of all cladding materials including brick, travertine, granite, aluminum, and pre-cast concrete. Figure 1a shows a portion of Houston's central business district where a large amount of glass damage occurred. Wind speeds in this area did not exceed code values as seen in Figure 1b [4]. Structurally, all of the high-rise buildings performed extremely well. Damage to these buildings was limited to glass cladding and the streets in this area were littered with glass pieces, sheet metal sidings, and other rooftop accessories. The most seriously damaged areas of the 71-story, glass-clad Allied Bank Building were concentrated on the southeast and southwest faces, up to approximately the 40th floor (Fig. 2a). Approximately 3000 glass panes were replaced. Broken panes that remained intact after the storm exhibited fractures consistent with those caused by small missiles.

Figure 1. a) Central business district of Houston. Excessive cladding damage in bold. b) Wind speed contours in Houston-Galveston area. Values are fastest mile (mph) at 33 ft (10 m) height [2,4].

As seen in Figure 1b, fastest mile wind speeds at 33ft (10m) were estimated at 80 mph (36 m/s) in and around the central business district of Houston during Hurricane Alicia [4]. ANSI-82 indicated a fastest mile design wind speed of 90 mph (40 m/s) in this area [4,7]. The Hong Kong observatory obtained information on the wind field for Typhoon York from numerous anemometer stations in the Hong Kong area. Wind speeds for various averaged durations are listed in Table 1 [3,8]. The data from Waglan Islands, with topographical correction, possibly provides the best information regarding typhoon wind speeds over open water given its isolated location while Central Plaza [3] and Di Wang Tower [8] data provide information on wind speeds approximately 380 m above sea level. The mean hourly wind speeds recorded at Central Plaza and Di Wang did not exceed the value specified by a practice note issued by the Hong Kong Building Department indicating a mean hourly wind speed of 64 m/s (143 mph) for a 50 year return period at a gradient height of 300m [8]. During Hurricane Alicia and Typhoon York, design wind speeds were not exceeded yet damage to building cladding remained excessive and costly.

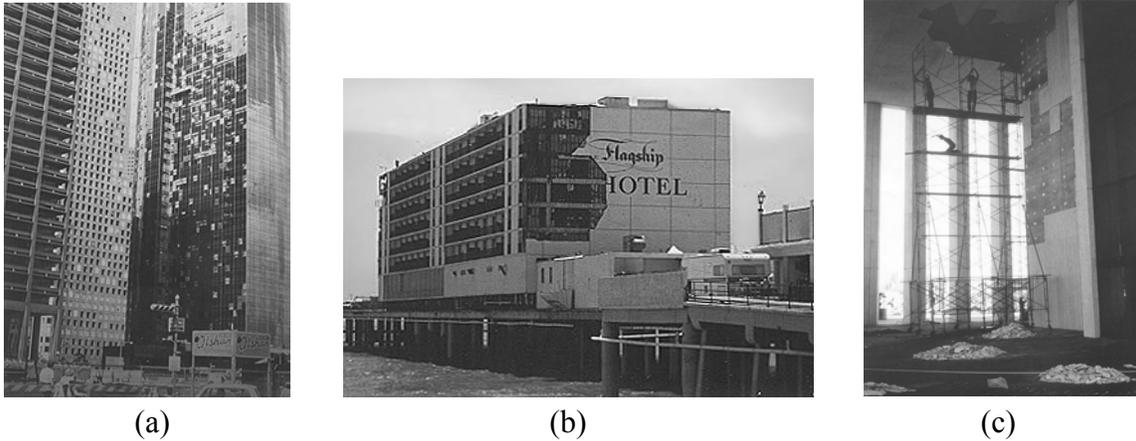
The 51-story InterFirst Tower suffered severe damage to approximately 650 glass panels located on the northeast and southeast faces (Fig. 2a). In addition, after Hurricane Alicia, workers knocked out the remaining glass from damaged windows and allowed it to fall to the street below

Ironically, this facilitated additional damage to the windows long after the hurricane had left the

Figure 2. a) Allied Bank and InterFirst Tower b) Flagship Hotel c) Lobby of the American National Insurance Building

area. The Flagship Hotel exhibited extensive damage to large non-glass cladding panels (Fig. 2b). The American National Insurance Building, located behind the seawall in Galveston suffered glass damage as well as damage to stone cladding in its recessed lobby. Large granite panels were dislodged from their seatings and ceiling tiles were damaged (Fig 2c).

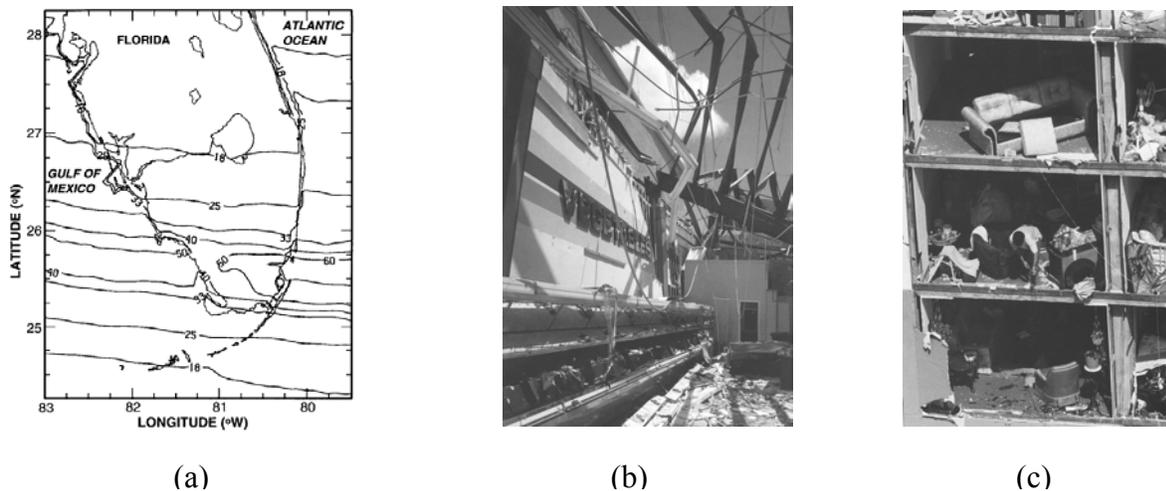
Hurricane Andrew devastated southern Florida in 1992 and caused a tremendous amount of damage. In Figure 3a, the peak fastest mile wind speed over open terrain was estimated at 60 m/s (134 mph) and is considered to be an upper bound value [5]. The annexed structure in Figure 3b was damaged as a result of a weak structural system. The high-rise residential structure in Figure 3c lost exterior walls facilitating additional damage to interior contents.

Figure 3. a) Fastest mile wind speeds for Hurricane Andrew (m/s) over open terrain [5]. b) Building damage caused by neighboring structure. c) Residential high-rise structure damage after Hurricane Andrew.

During Hurricane Andrew peak fastest mile wind speeds were estimated at 134 mph (60 m/s) in the Miami area while ASCE 7-88 designated a fastest mile design wind speed of 110 mph (49 m/s) in this region[5,9]. These speeds were not widespread and a majority of the region was subjected to fastest mile wind speeds in the range of 90-112 mph (40-50 m/s) [5]. Although design wind speeds appeared to have been exceeded at times during the passage of Hurricane Andrew in 1992, the current code, ASCE 7-02, designates a 3-s gust equivalent to a fastest mile wind speed of 122 mph (55 m/s), slightly less than Andrew's peak but greater than the predominant wind speeds observed in southern Florida [10].

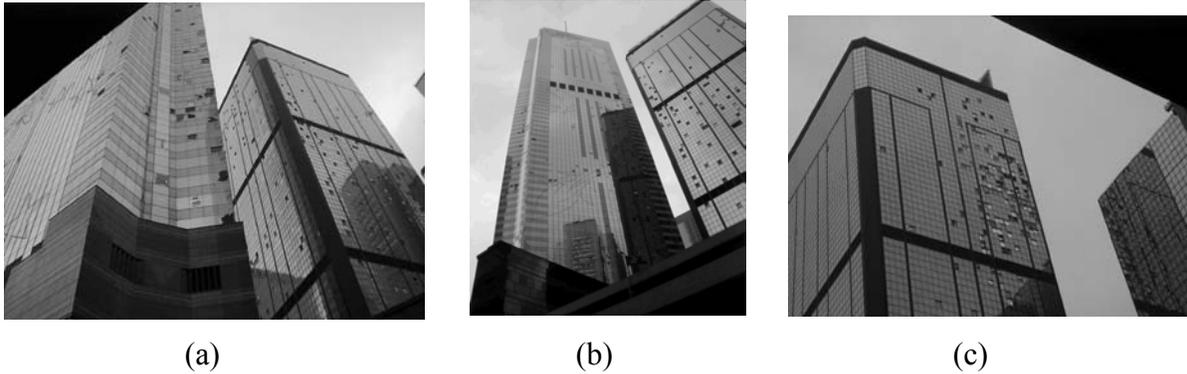
On September 16, 1999, Typhoon York wreaked havoc in Hong Kong causing an abundance of damage to prominent buildings on the island. The wind direction changed from northeast to southwest over the course of the storm. Central Plaza, then Hong Kong's tallest building, lost many glass panels (Figs. 4a & 4b). Nearby, the Great Eagle Center and Harbor Center buildings were missing pieces of flashing on the upper regions of both buildings which may have possibly caused more damage to surrounding buildings in the area. The convention center exhibited damage to panels on the underside of the roof. Figure 4c shows a close up view of glass damage to the exterior of the Immigration building.

Figure 4. a) Damage to Central Plaza and Immigration buildings. b) Close up view of glass damage to Central Plaza. c) Close up view of damage to the Immigration building.

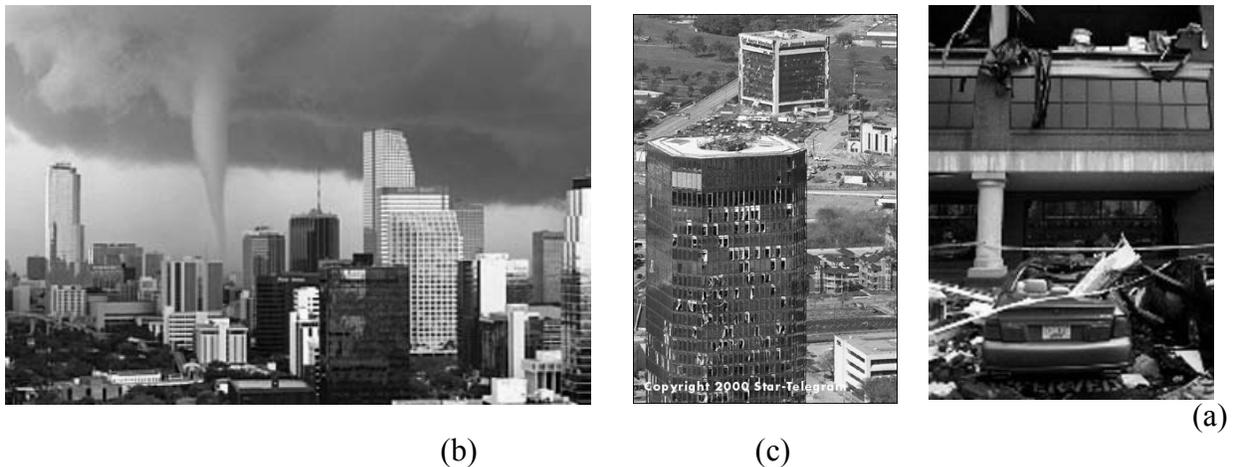
Tornadoes, in addition to hurricanes and typhoons, can also have a major impact on urban areas. Although it was previously thought that urban areas were virtually immune to tornado threats, perhaps due to heat island effects, recent incidents in Nashville, Tennessee, the Dallas/Fort Worth area of Texas, Salt Lake City, Utah, and Miami, Florida have led to heightened awareness of such occurrences. Figure 5a shows a dramatic photograph taken of the tornado that swept through the outskirts of downtown Miami, FL on May 12, 1997 causing glass damage to numerous buildings. When a tornado weaved its way through downtown Fort Worth, TX on March 28, 2000, virtually all of the exterior windows of the Bank One building were damaged by winds and wind borne debris (Fig. 5b) as well as the Cash America building. Figure 5c shows building damage and accumulation of debris from the tornado that struck Nashville, TN on April 16, 1998.

Figure 5. a) Downtown Miami, Florida. (Reproduced from www.usatoday.com/weather/wtmiami.htm AP Photo/The Miami Herald) b) Bank One building in Fort Worth, TX. (Reproduced from www.star-telegram.com/specials/00storms) c) Building Damage and debris in Nashville, TN. (Reproduced from www.drytech.com/tornado.htm)

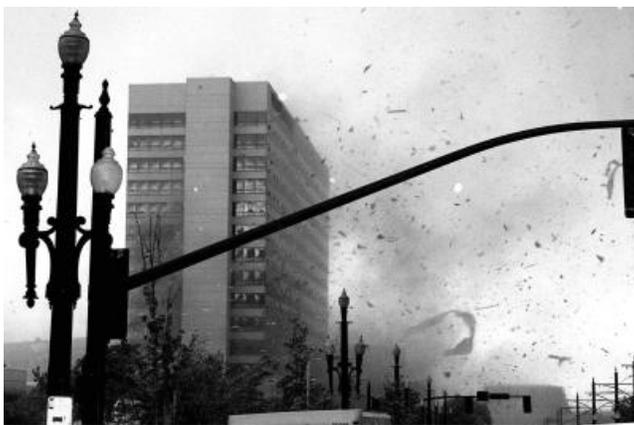
(a)

Figure 6a demonstrates the variety and amount of debris that can be present during an extreme wind event. This debris cloud created during the tornado that struck Salt Lake City, UT contains everything from small particulate matter to large strips of sheet metal siding. The photograph is a dramatic representation of the amount of wind borne debris that may be present during a storm and the amount of cladding damage that may result.

Figure 6. a) Debris cloud during tornado in Salt Lake City, UT. (Photo by David Hsieh (Reuters) Reproduced from hpcsun.unl.edu/nebraska/SLCtornado.html) b) Broken windows due to poor performance of glass as observed at the John Hancock building, Boston, MA.

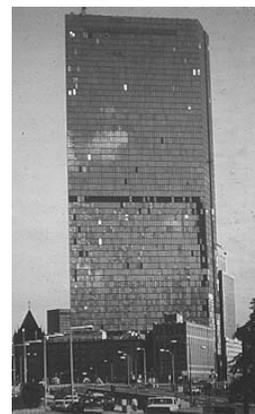
(b)

Another possible source of glass damage extends from poor glass performance under dynamic stresses induced by the external pressure, structural movement, or improper installation. A classic example is the John Hancock building in Boston where purportedly, improper glass design and installation led to the failure of a large number of glass panels (Fig. 6b). As a result, every glass panel was eventually replaced and for a short time the building was nicknamed the plywood palace. The major contributors to the complexity of structural glass behavior to wind loads are its brittle failure mechanism, variable breaking strength, load duration, strength degradation, and spatiotemporal fluctuations in wind pressures. These complexities create difficulty in accurately determining a failure cause as that from inadequate strength. However, this does not eliminate inadequate glass strength as a possible source of damage.
