1 **Experimental and Numerical Evaluation of the** 2 **Effect of Rail on the Behavior of Girder Bridges**

5 **ABSTRACT**

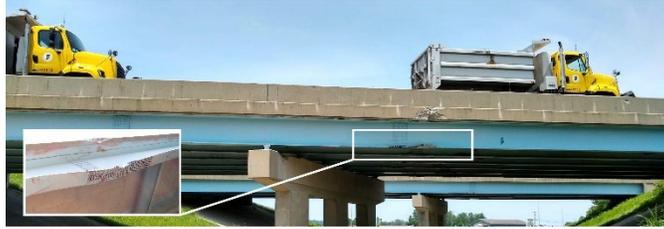
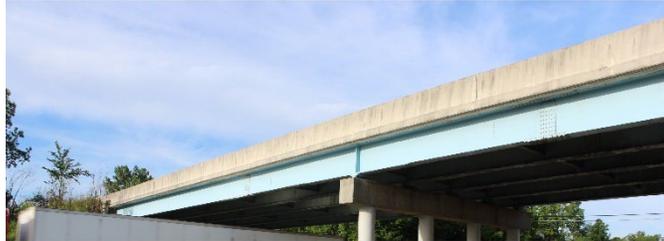
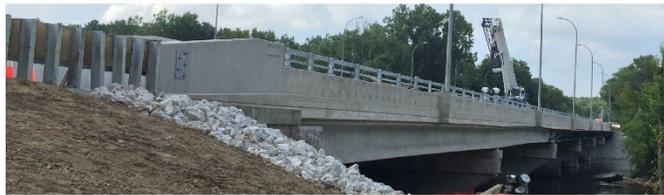
918
919
920 Figure 1. Monitored bridges.

182 Field monitoring was performed on one steel girder bridge, one steel girder bridge
183 damaged by vehicular collision, and one prestressed concrete girder bridge (Table 1). Bridges
184 will be identified by their INDOT asset numbers in this paper.

285 Asset 037-55-05265 (Figure 4a) is a two-span [each span is 21.3 m (70 ft.)] continuous,
286 composite, steel girder bridge that was built in Martinsville, IN in 1966 and then reconstructed in
287 1990. It features FC rail, which is discontinuous above the pier. As the FC rail replaced an
288 original rail for this bridge, there are slightly different dimensions for this rail, as shown in
