# **Failure in Structural Steels and Overview of I-35W**

## **Bridge Collapse**

Jack Przywara, University of Notre Dame

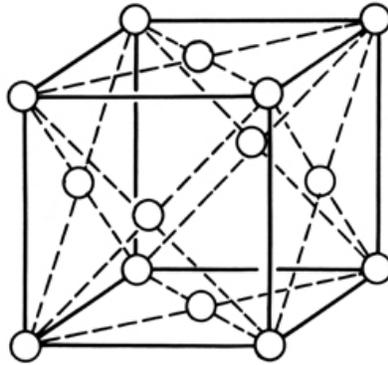
**Figure 1: Atomic scale diagram of crystal structure of a typical structural steel<sup>9</sup>**

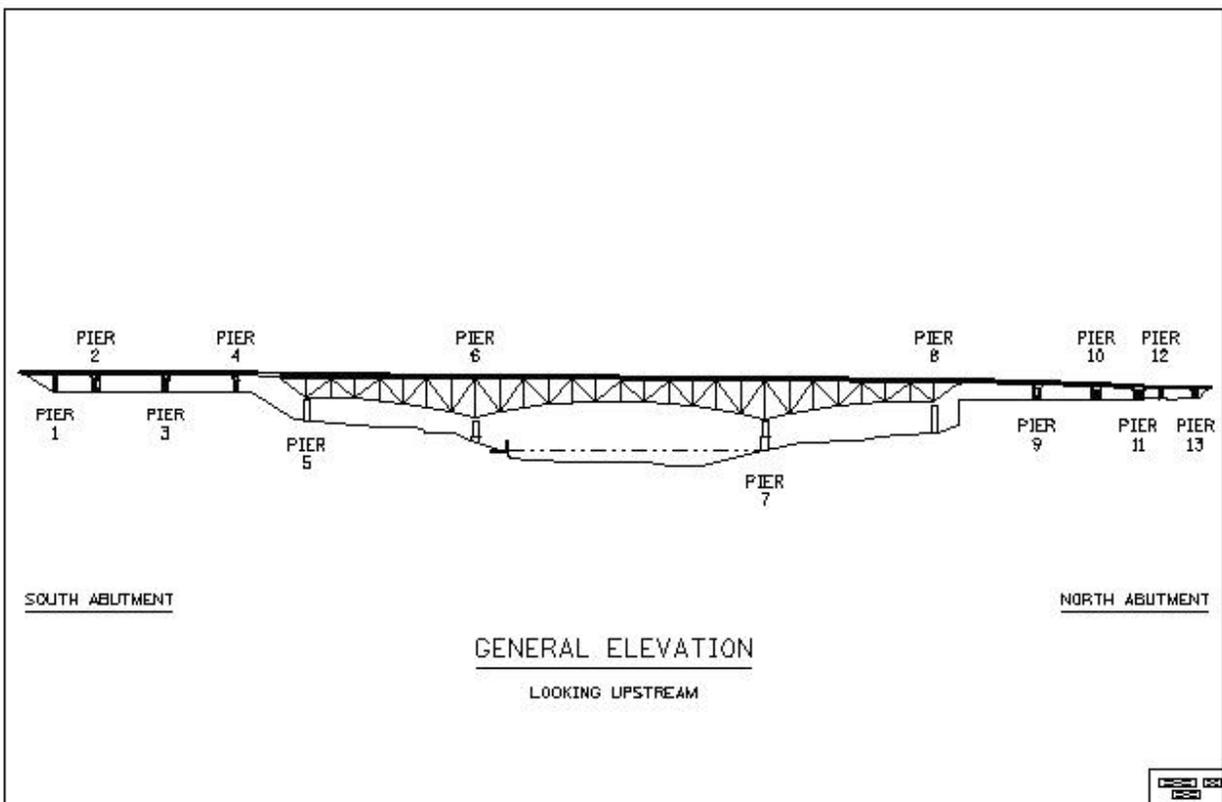
The I-35W bridge was composed of 14 spans with a total length of 1,907 feet. The total length of the bridge can be split up into three parts: the south approach spans, the north approach spans, and the deck truss spans over the river. Figure 4 shows a general elevation of the bridge looking upstream. The south approach spans are the part of the bridge from south abutment to between pier 4 and pier 5, the north approach spans are the part of the bridge from between pier 8 and pier 9 to the north abutment, and the deck truss spans are the part of the bridge from between pier 4 and pier 5 to between pier 8 and pier 9.

**Figure 4: Elevation of entire length of bridge from south abutment to north abutment**

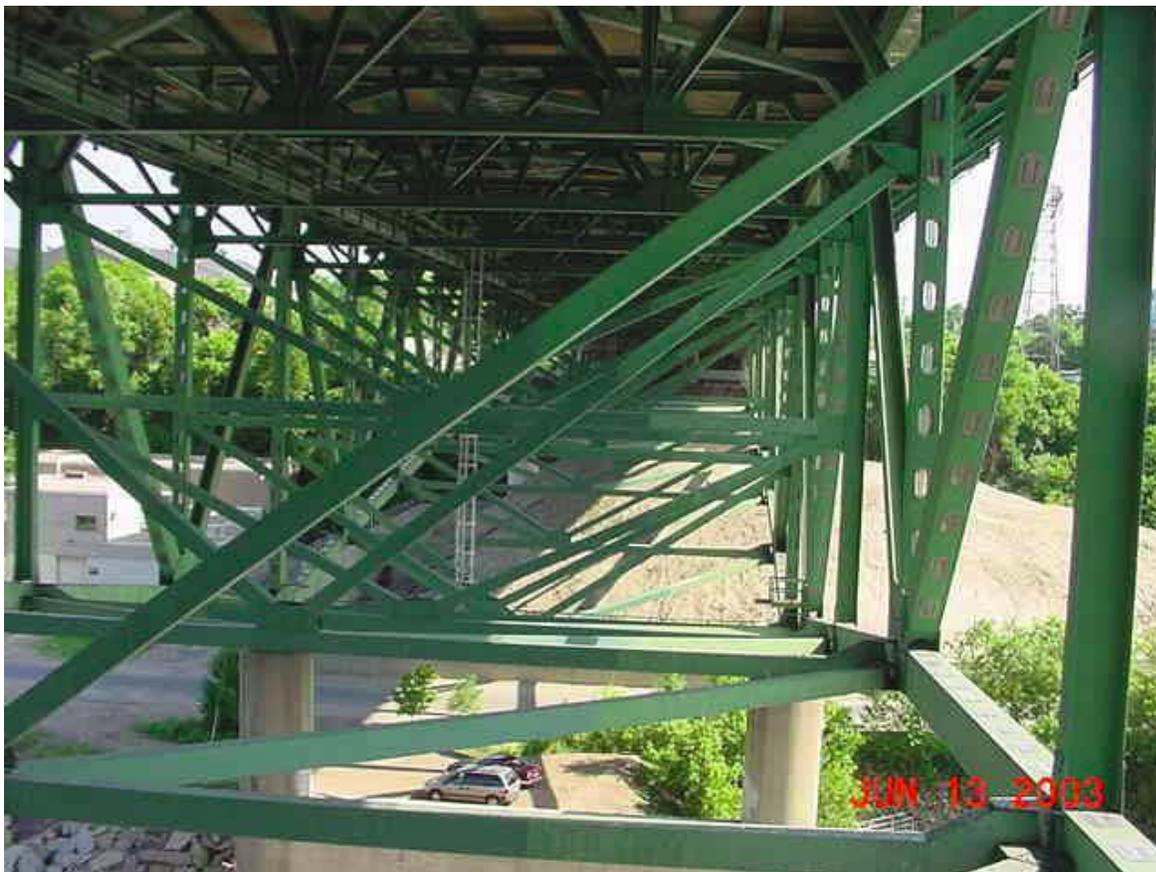
**Figure 5: Interior structure of north portion of deck truss**

The main structure of the deck trusses were two Warren-type trusses with verticals that rested on four large bearings.<sup>33</sup> These bearings were supported each supported by a pier that contained two round columns. Pier 5 and pier 8 each rested on footings embedded in rock, while pier 6 and pier 7 both rested on concrete shaft walls. This main structure of the bridge was composed of two identical side-by-side trusses of three spans each. Both trusses were also symmetrical about their center axis and slope downward from south to north for a decrease in elevation of slightly more than 7 feet. The depth of the truss at each end support is 30 feet, varies parabolically to 60 feet at the two interior supports, and again varies parabolically until it reaches a depth of 36 feet at the center point of the main span. Each truss was divided into 28 panels, all of which are exactly 38 feet in length, with transverse welded floor trusses connecting the two trusses at each of these locations. Vertical members are also located at these points extend the entire depth of the truss at their respective locations. Every panel also has a single diagonal member that extends from opposite corners of the panel. The orientation of these diagonal members are changed each panel so that they form a series of Warren-type triangle shapes along the lengths of both trusses. Finally, there are members on the top and bottom of each panel.<sup>34</sup> Figure 6 shows the elevation of the deck truss design, as well as which members of the deck truss are in tension, which members are in compression, and which members experience both.

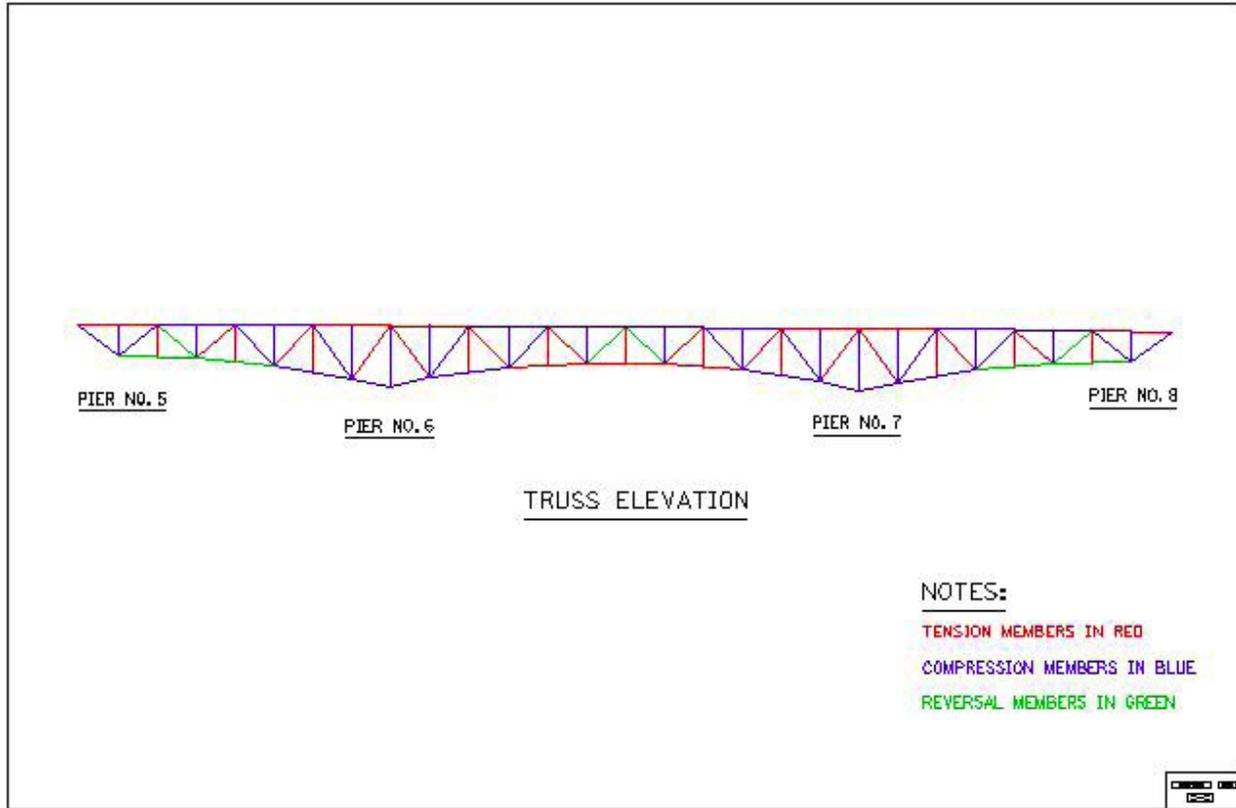
**Figure 6: Tension and compression members of the deck truss portion of the I-35W bridge**  
 \*Figure courtesy of National Transportation Safety Board (NTSB)<sup>35</sup>

The deck truss was made up of different types of members. The individual horizontal members, called chords, were welded box sections that were 28 inches deep by 21 inches wide. The diagonal and vertical members that were in compression were also welded box sections, but the diagonal and vertical members that were in tension were welded I-shapes. In order to connect these members at a connection point, the truss chords, verticals, and diagonals were all riveted to large gusset plates that varied in thickness from ½” to 1”.<sup>36</sup> These gusset plates connected members at 112 different nodes on the deck truss portion of the bridge. There were two gusset plates at each node, or connection point, with one gusset plate on each side of the node. They were riveted to the side plates of the box members and the side plates of the I-shaped members. However, at some locations, bolts were used instead of rivets in order to facilitate construction.<sup>37</sup>

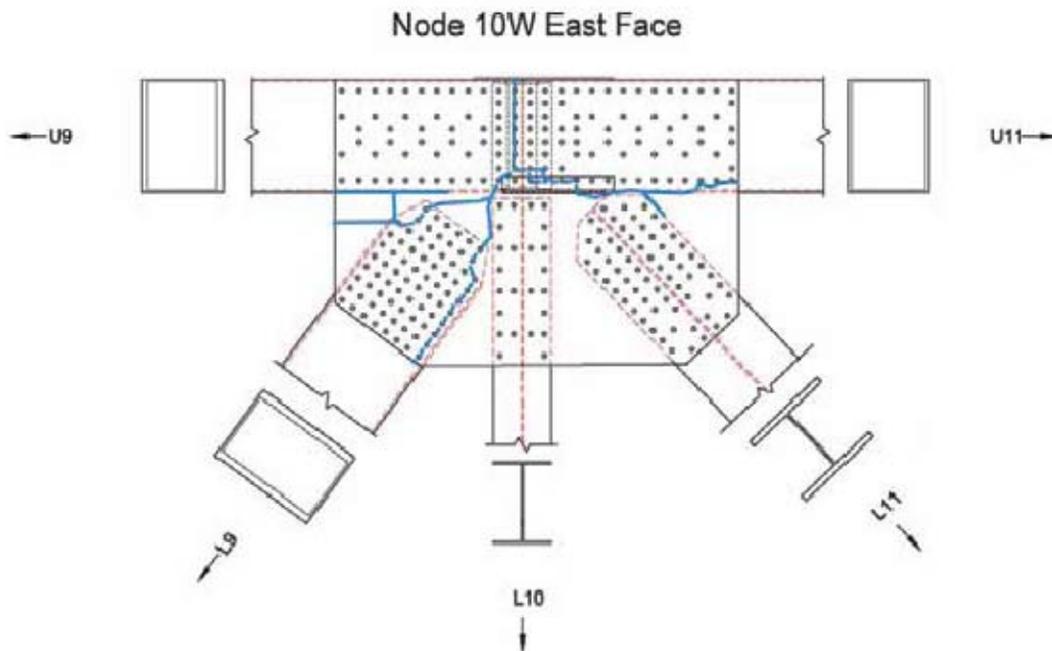
In the fracture area just north of pier 6, it was found that all four of the gusset plates at a node were fractured due to fatigue cracking and overload. This eventually led to a cleavage fracture. The fracture pattern from one of the gusset plates is shown in figure 7. Upon fracture, two diagonal members and two upper chord horizontal members separated from the rest of the members at the node location. The loss of structural support due to this separation caused structural deformation to begin in the deck truss south of this location. This led to a chain-reaction of overloading by either compression or tension, thus causing several structural members to fracture as well. The failure of the southern part of the middle span caused a similar failure process in the northern part of the middle span just south of pier 7. A node at this location also experienced fracture in all four gusset plates that connected the structural members together due to fatigue cracking and overload, causing a cleavage fracture. Once again, this overloaded several of the structural members, causing them to fracture due to too much tensile or compressive stress. These fractures caused a total separation of the center span of the bridge,

**Figure 7: Inside east gusset plate at node U10W showing similar fracture patterns**

The National Transportation Safety Board (NTSB) concluded that the initial event causing the collapse was a lateral shifting instability of the upper end of a diagonal member in the southern portion of the center span. Another conclusion reached was that the failed gusset plates where the collapse initiated were inadequate to support the structure as the bridge was originally designed, let alone modifications and renovations that were made. This inadequacy was attributed to an error by the design firm that was not caught by government inspectors and other forms of design checks, even though they had several opportunities. NTSB also concluded that the total collapse of the deck truss was likely once the gusset plates failed since the deck truss portion was designed to be “non-load-path-redundant.”<sup>39</sup>
